BUILDING PERFORMANCE: HURRICANE ANDREW IN FLORIDA

**OBSERVATIONS, RECOMMENDATIONS,
AND TECHNICAL GUIDANCE**

**FEDERAL EMERGENCY MANAGEMENT AGENCY
FEDERAL INSURANCE ADMINISTRATION**

DECEMBER 21, 1992

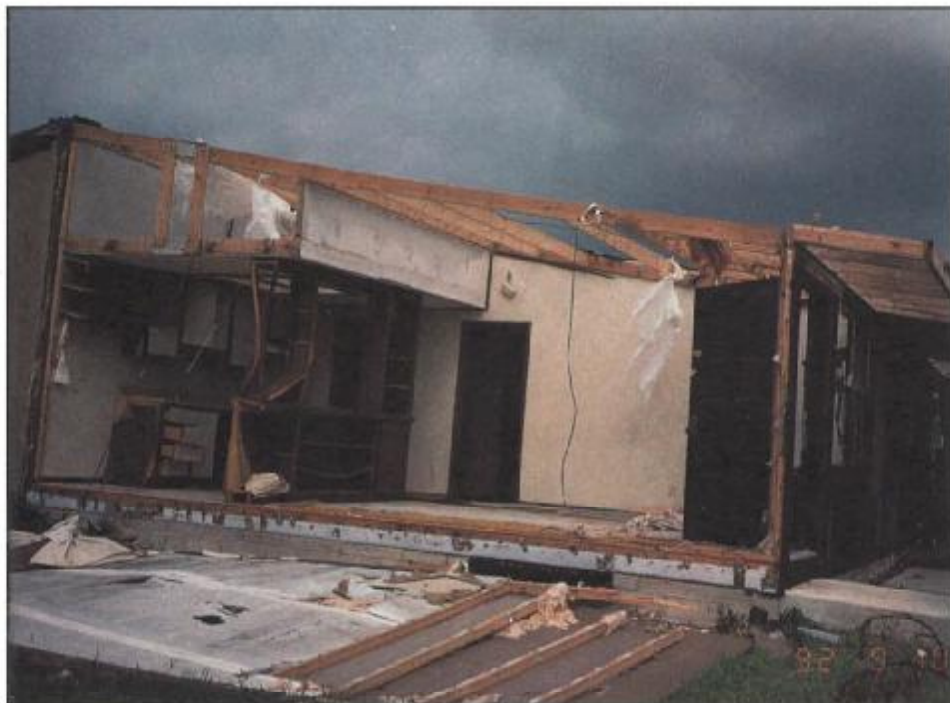
Two end-wall (end wall of end modules) failures were observed in a modular home subdivision. Poor connection of the tops of the walls to the roof diaphragms was evident in these instances. Some roof sheathing was observed missing from rafters, judged to be due either to building envelope breach (window and/or door failure) or to external wind and debris. Generally, the rafters themselves were left entirely intact, because of the inherent rigidity developed by the relatively short spans and secure connections. (SEE FIGURES 19 AND 20.)

FIGURE 19. Modular home. End wall of end unit separated from unit; withdrawal of nails along eave line and roof sheathing failure were also observed.
